LANDSLIDES AND RELATED FEATURES

OF THE SAVAGE POINT, TENN. QUADRANGLE

by
Roger F. Thomas
1981

U.S. Geological Survey
OPEN FILE MAP 81-1318 (D-5)

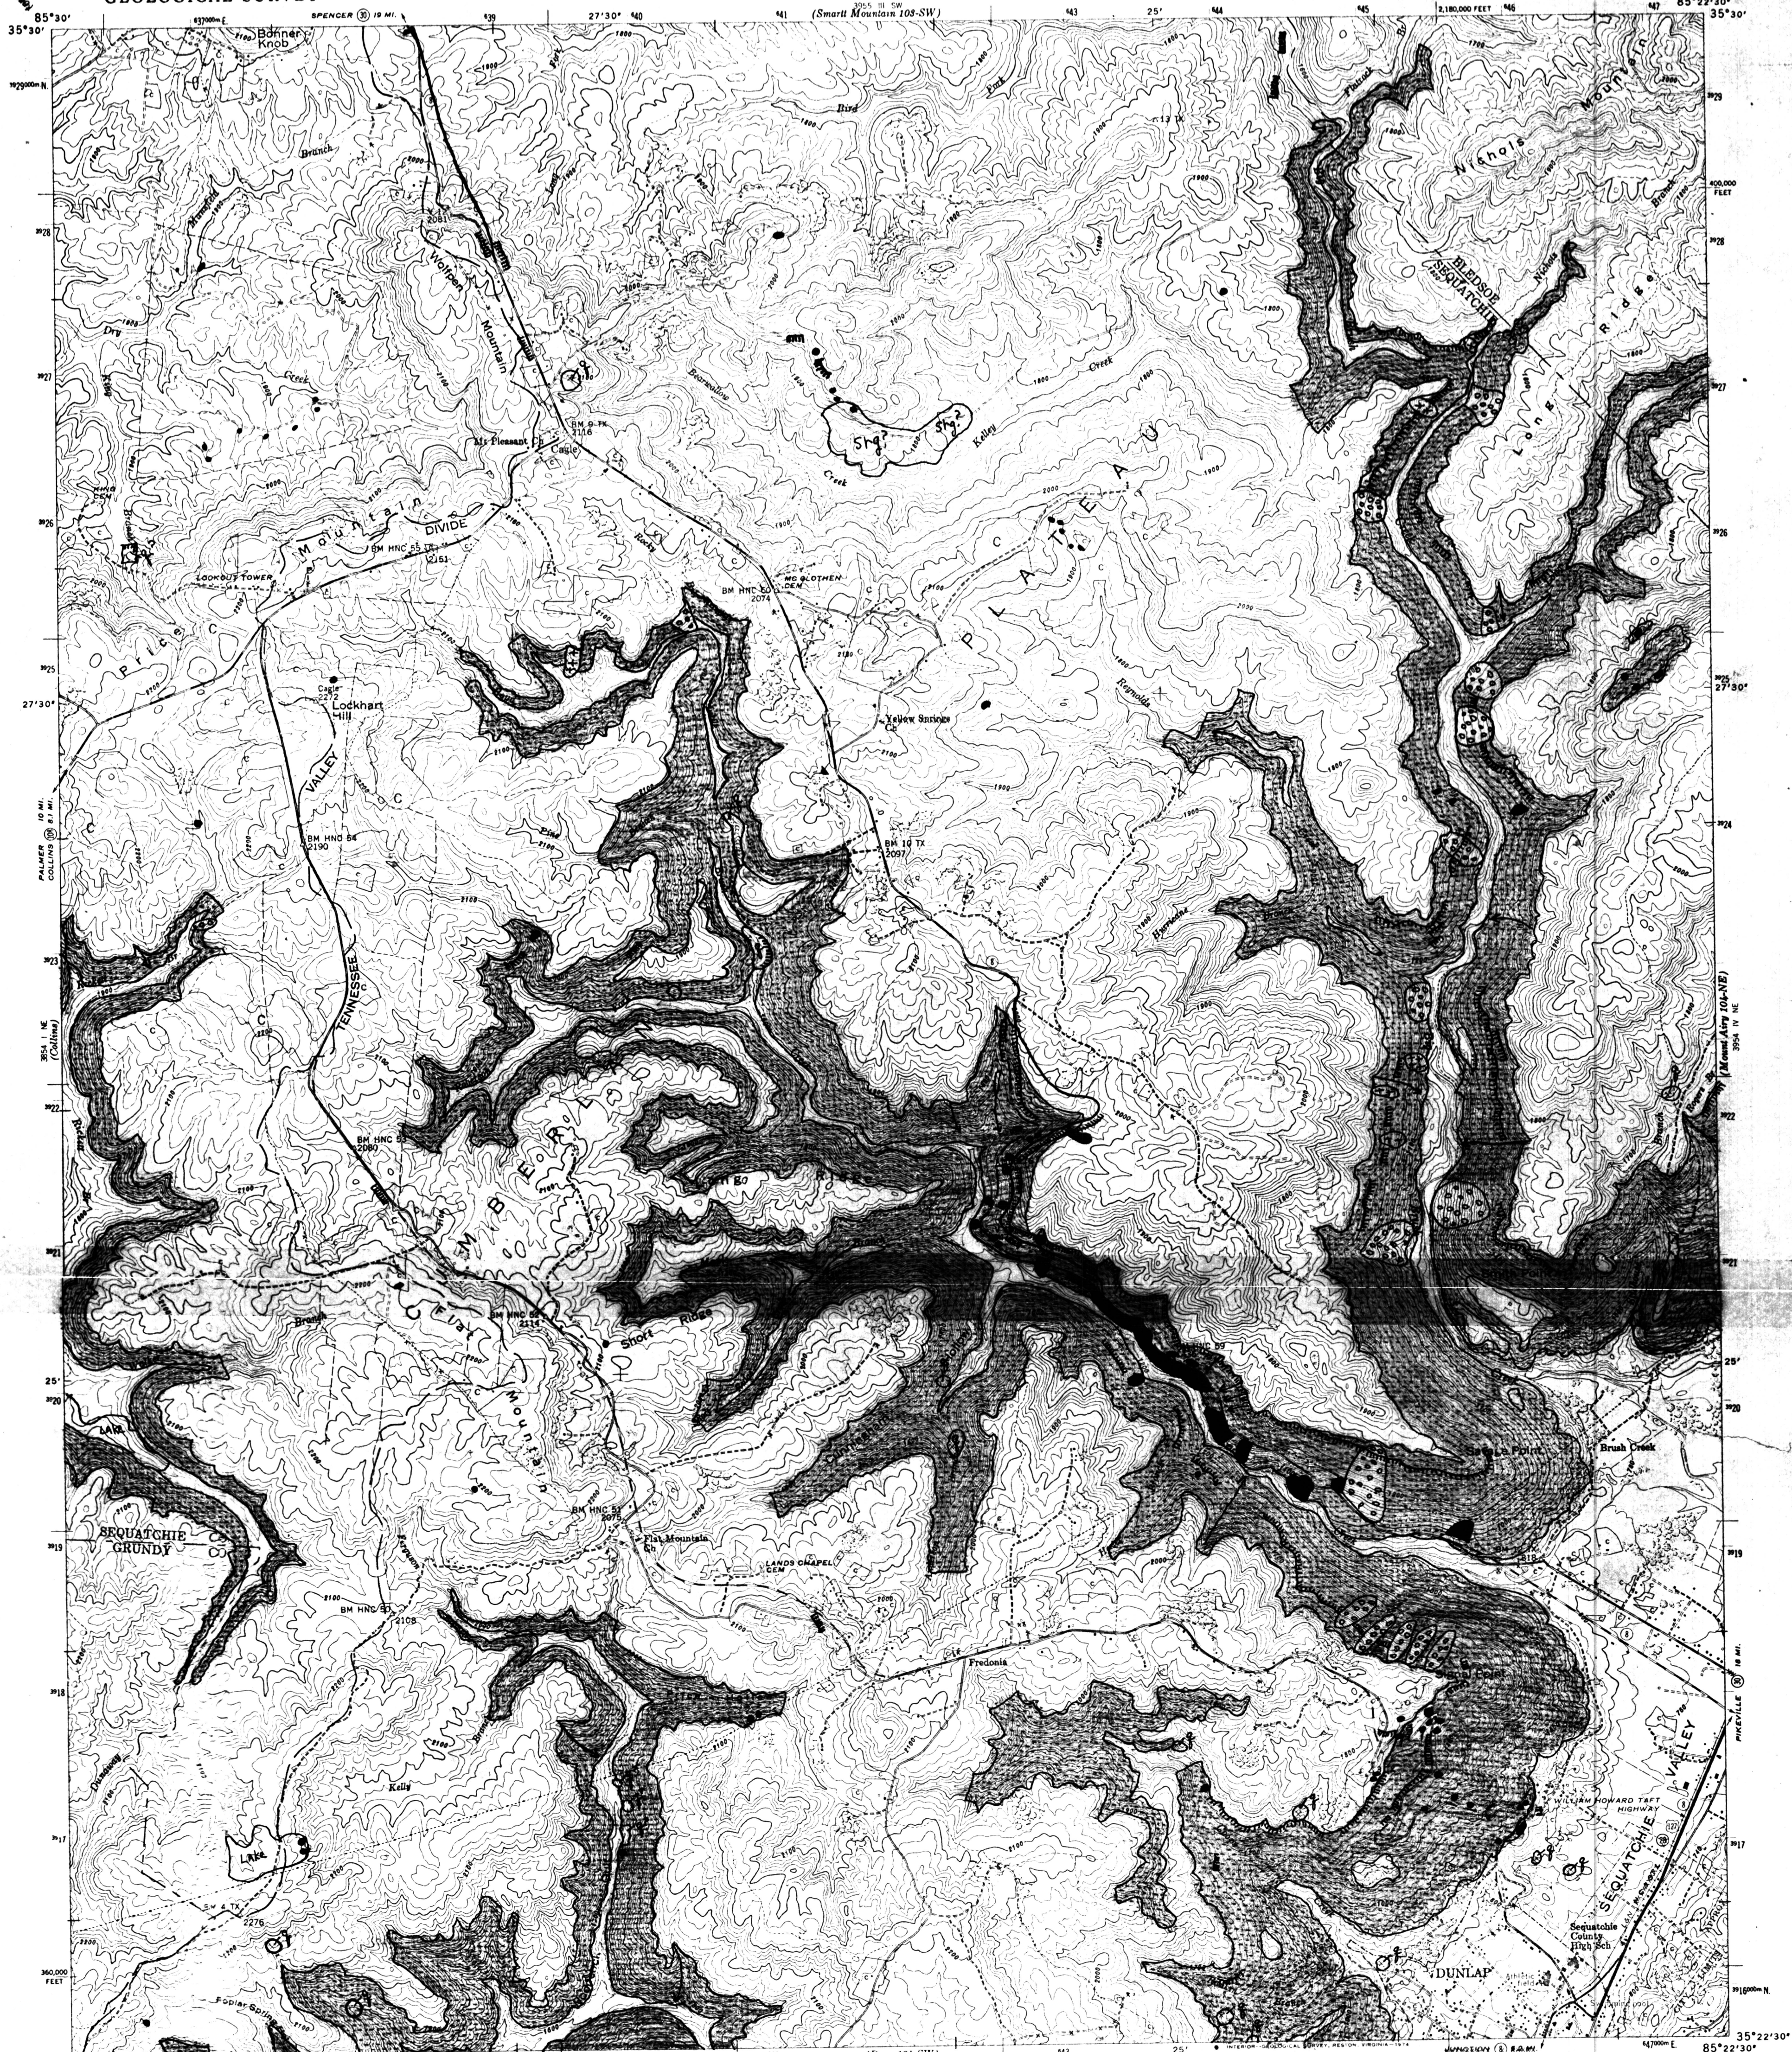
Landslides and related features interpreted
from aerial photographs:
1:79,000 (Black and White) 1974
1:20,000 (Black and White) 1970

Photointerpretation and field check 1981
This report is preliminary and has not
been reviewed for conformity with U.S.
Geological Survey editorial standards.

ACTIVE OR POTENTIALLY ACTIVE LANDSLIDE
Complex landslide composed of earthflow, debris
slide, earth and rock slump. Identified from
historical records, and from scars, debris and
other field evidence. Ground extremely unstable;
sliding accelerated by excavation, loading and
changes in drainage conditions. May include
areas with several active slides too small to
be shown separately. Questioned where doubtful.

OLD LANDSLIDE
Area of extensive hummocky ground caused by
earthflow and earth and rock slump. Lacks
clear evidence of active sliding. Relatively
stable in natural, undisturbed state,
generally not affected by small structures properly
sited in areas away from the edge of the toe;
can be reactivated by extensive, rapid exca-
vation, loading, and changes in ground water and
surface water conditions. Area of old landslide
probably includes recent ones not identified
from field evidence or otherwise documented.
Upslope boundary of landslide generally defined
by modified scarp, but downslope (toe) may be
gradational and not well defined. Questioned
where doubtful.

COMBINATION LANDSLIDE
Area of recent and old slides in which
individual slides are not identified.

COLLUVIAL SLOPE
Valley wall along major streams with slope as
steep as 40 (85%); stony, clayey silt soil up
to 50 ft. (15 m) thick; commonly buttressed by
a terrace or bench at the toe of the slope; very
susceptible to sliding by cutting of toe area,
removal of terrace or bench, and overloading;
slide commonly activated without apparent cause.

COLLUVIAL SLOPES WITH LANDSLIDES
Landslides too small or obscure to map
individually.

**AREAS SUSCEPTIBLE TO DEBRIS FLOWS AND DEBRIS
AVALANCHES**
Primarily shallow, narrow ravines and chutes with
accumulation of stony colluvium generally 10 ft.
(3 m) or less in thickness; susceptible to rapid
movement during intense rainfall. Most ravines
and chutes designated show evidence of former
debris flows and avalanches.

AREAS SUSCEPTIBLE TO ROCKFALL
Steep, locally vertical, natural and man-made
slopes and cliffs, 15 ft. (4.5 m) or more high;
formed dominantly of sandstone, limestone, sandy
shale, mudstone and claystone. Interbedded mud-
stone, claystone and shale weather rapidly leaving
sandstone and limestone rock faces unsupported.

SOIL AND ROCK SUSCEPTIBLE TO LANDSLIDING
Soil and rock similar to that involved in land-
slides elsewhere in map area; primarily areas
underlain by claystone, mudstone and shale
associated with other rock types. Rock weathers
rapidly on exposure forming clayey soil highly
susceptible to sliding. Includes coves (U-shaped,
shallow valleys) containing thick layers of clayey
soil that are very susceptible to sliding where
excavation breaks continuity of slope and where
overloaded by artificial fill.

AREAS LEAST PRONE TO LANDSLIDES
Map areas in which no patterns or symbols are shown;
primarily valley floors, ridge tops and broad
benches; modification by excavation and fill may
lead to local landslides.

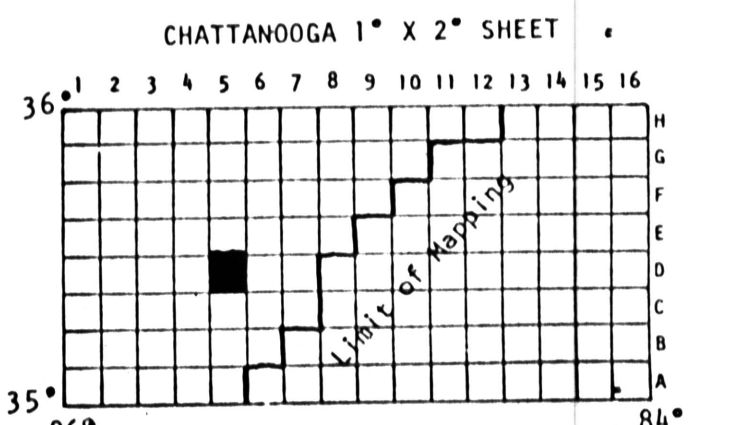
The first six digits of the open file number designate the
specific 1:250,000 scale map sheet of which this quadrangle
is a part. The last two digits designate the position of the
quadrangle in a subdivision of the 1:250,000 scale map based
on rows and tiers shown in the diagram to the right. The
location of this quadrangle is shown by the black square.
